# The effect experiments of CCD imaging system against high power electromagnetic pulse

Ping Wu, Cui Meng\* Key Laboratory of Particle & Radiation Imaging, Ministry of Education Department of Engineering Physics, Tsinghua University Beijing, China, 100084 p-wu16@mails.tsinghua.edu.cn

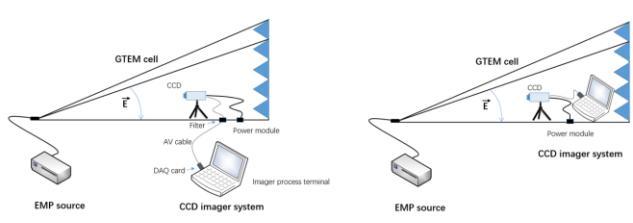
Fig. 1. Experiment setup of GTEM cell. (a) CCD imager was isolated and undergo radiation of EMP; (b) whole CCD imager system was undergo radiation of EMP.

In this paper, CCD imager was chosen as the typical example of diagnostic equipment. Consider both the simplification and integrality, a system constitutes by commercial CCD imager, AV data line, DAQ card and Image process terminal is build up as DUT. The incident HPEM field is excited by double-exponential high-voltage source and broadcasted by UWB(Ultra-wideband) antennas and GTEM (Gigahertz transverse electromagnetic wave) cell. Constituent parts of imager system were isolated or settled together against the incident pulse in different experiment settings to explore the effect contribution of those parts.

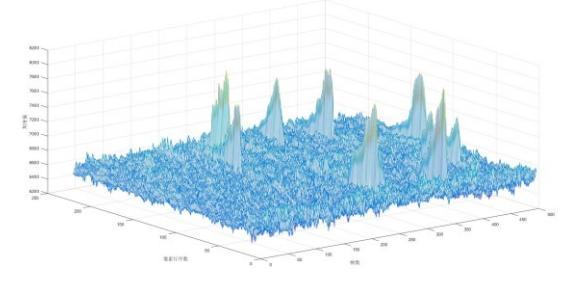
Fig. 2. Pixel luminance distortion extract from time domain grey level analysis.

During the HPEM test, lots of malfunction phenomena and a few of destruction cases were observed. The destruction cases happen in the test of UWB in which field strength reaches up to 100 kV/m. The DAQ card kept inside shielded enclosure was still found burnout. Except for destruction cases, there are several malfunction and interference phenomena were observed, which include recording break, color distortion and row pixel flash. Image pixel grey level data was processed and at least 30% of pixel luminance distortion happened at the moment pulse incident. The minimum threshold of interference effects with different orientation is about 7 kV/m. the connection of interference effects and EMP environment describe factors will be further discussed.
